Aim of SOLAS

To promote safety of life at sea by establishing a common agreement for uniform principles and rules.

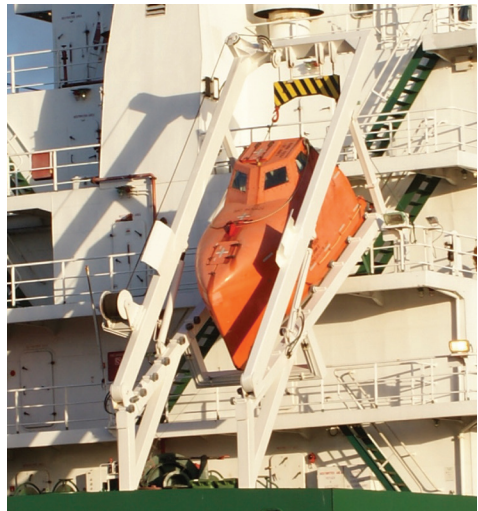
*Figure 1.6
SOLAS requires specific lifeboat capacities and capabilities*

As a result of the disaster, minimum standards for the provision of lifeboats and other life-saving appliances were put in place through SOLAS. This was the first step toward ensuring minimum standards in all areas of onboard safety and fire protection.

Passenger Vessels (International Voyages)	<i>Partially or totally enclosed lifeboats on each side, of such aggregate capacity as will accommodate not less than 50% of the total number of persons on board. Launching appliances shall be equally distributed on each side of the ship.</i>
Passenger Vessels (Short International Voyages)	<i>Partially or totally enclosed lifeboats of such aggregate capacity as will accommodate at least 30% of the total number of persons on board. The lifeboats shall, as far as practicable, be equally distributed on each side of the ship.</i>
Cargo Ships	<i>One or more totally enclosed lifeboats such that the aggregate capacity on each side of the vessel will accommodate the total number of persons on board or one or more free-fall lifeboats, capable of being free launched over the stern of the vessel, of such aggregate capacity as will accommodate the total number of persons on board.</i>

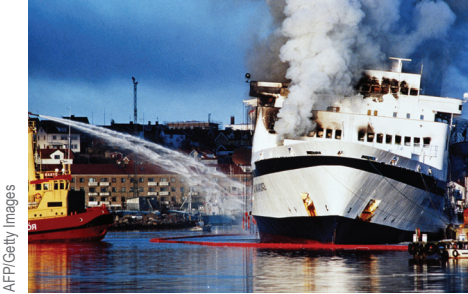
Figure 1.7

'Scandinavian Star' in dock in Lysekil – fire-fighting continues a day after the fire broke out

Attempts were made to contain the fire by automatically closing the fire doors on the deck (deck 3) that was affected by the initial fires. These attempts

failed as the doors could not be closed automatically and the situation was further compounded when the air conditioning system was shut down. It was thought that this action would cut off the supply of oxygen to the fire, but it increased the smoke in the passenger cabins, trapping many of the passengers.

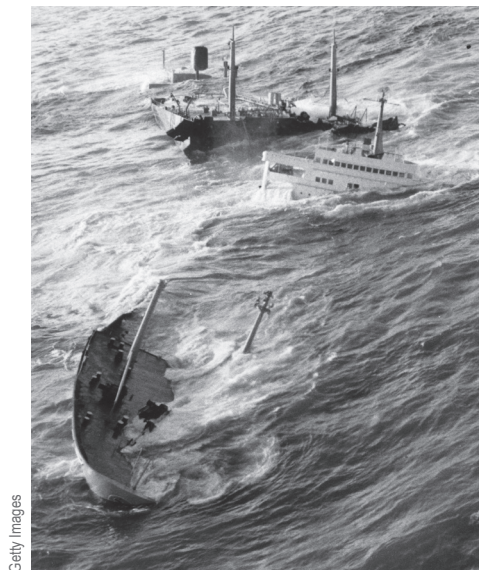
*Figure 1.9
The wrecked tanker ‘Torrey Canyon’*

The ‘Torrey Canyon’ was on passage from Mina Al-Ahmadi, Kuwait, to Milford Haven, UK when she struck Pollard’s Rock, off Land’s End, causing a major oil spill. The coastlines of both England and France were severely affected.

The vessel broke up and sank within a few days, but the damage to the marine environment had already been done.
